# COMMERCE CENTER 1S/4W-22J1-4

**Figure 4G.** Geophysical logs, lithology, and well construction for Commerce Center (1S/4W-22J1-4) multiple-depth monitoring well site, San Bernardino area, California.

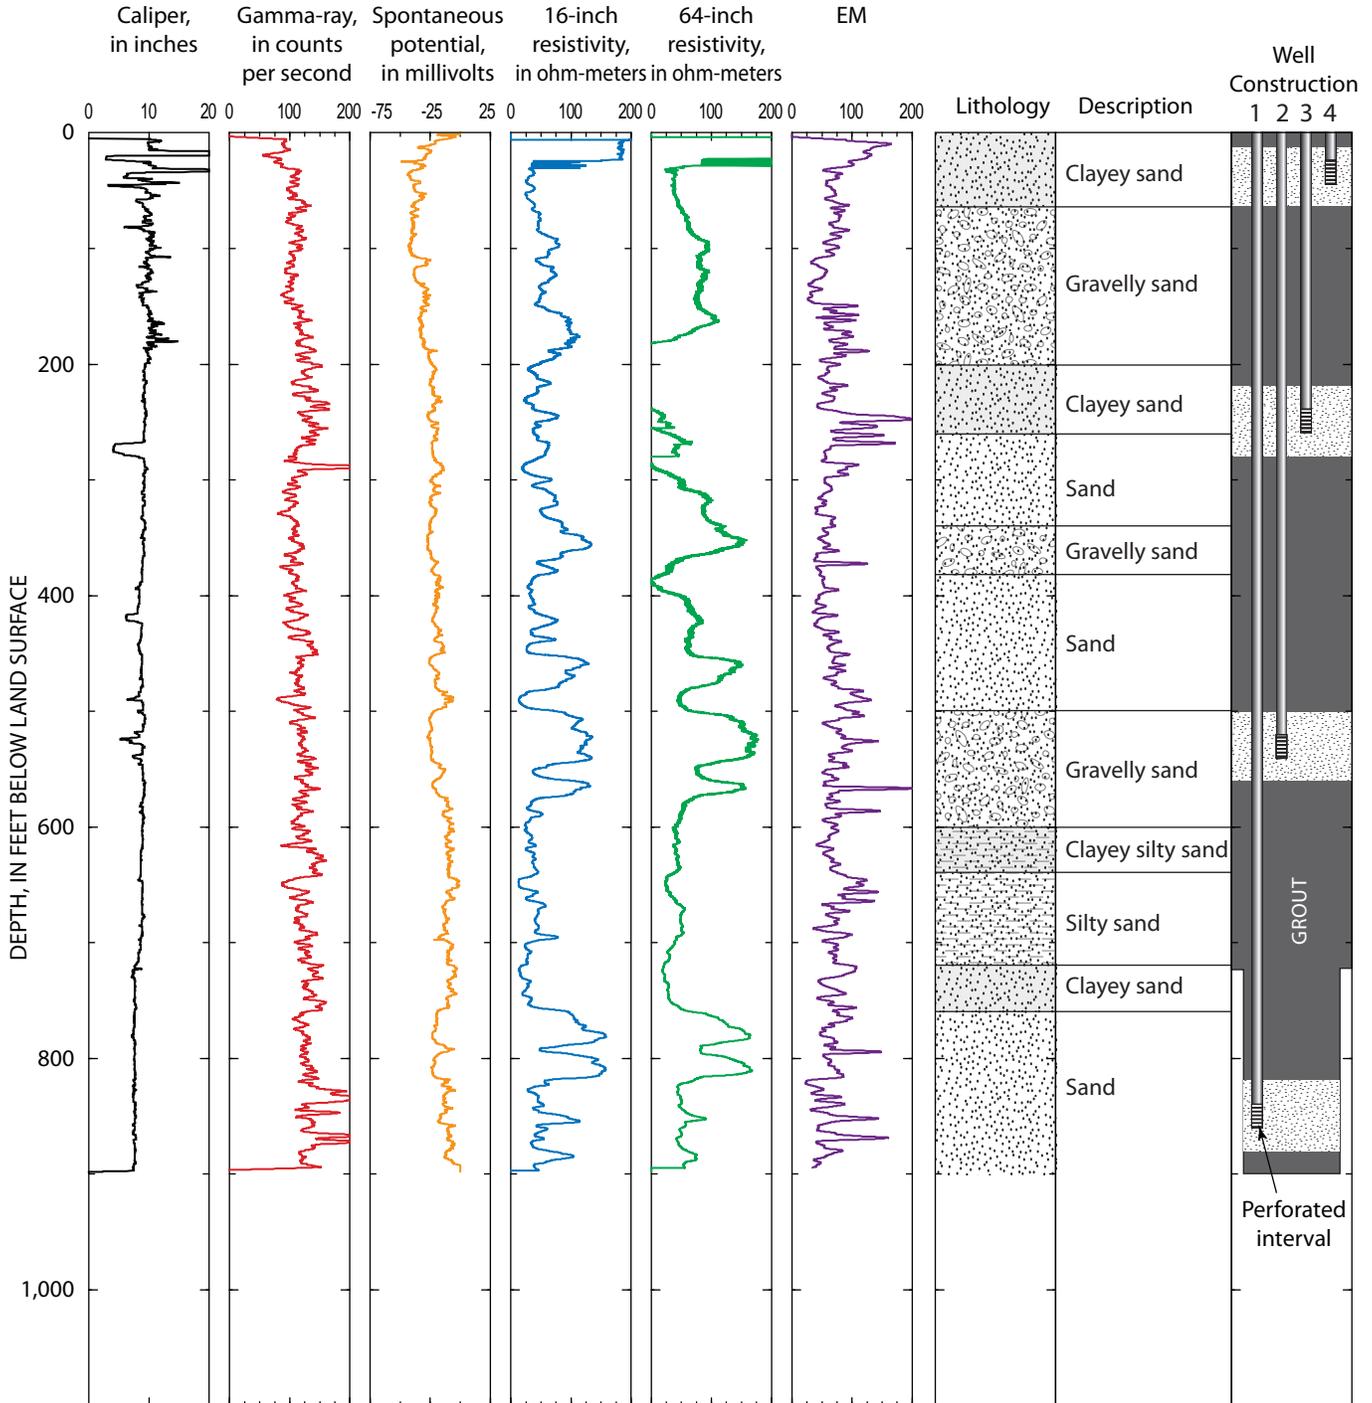
Note: Some lithologic units may have been combined for presentation in this figure and the lithologic description may not correspond exactly to the description in the lithologic log shown in table.
